Hardware Performance Analysis of the Basic Narrow Microwave Landing System (MLS) at Washington National Airport (DCA) in the Service Test and Evaluation Program (STEP)

September 1985

DOT/FAA/CT-TN85/19

Technical Center
Atlantic City Airport, N.J. 08405

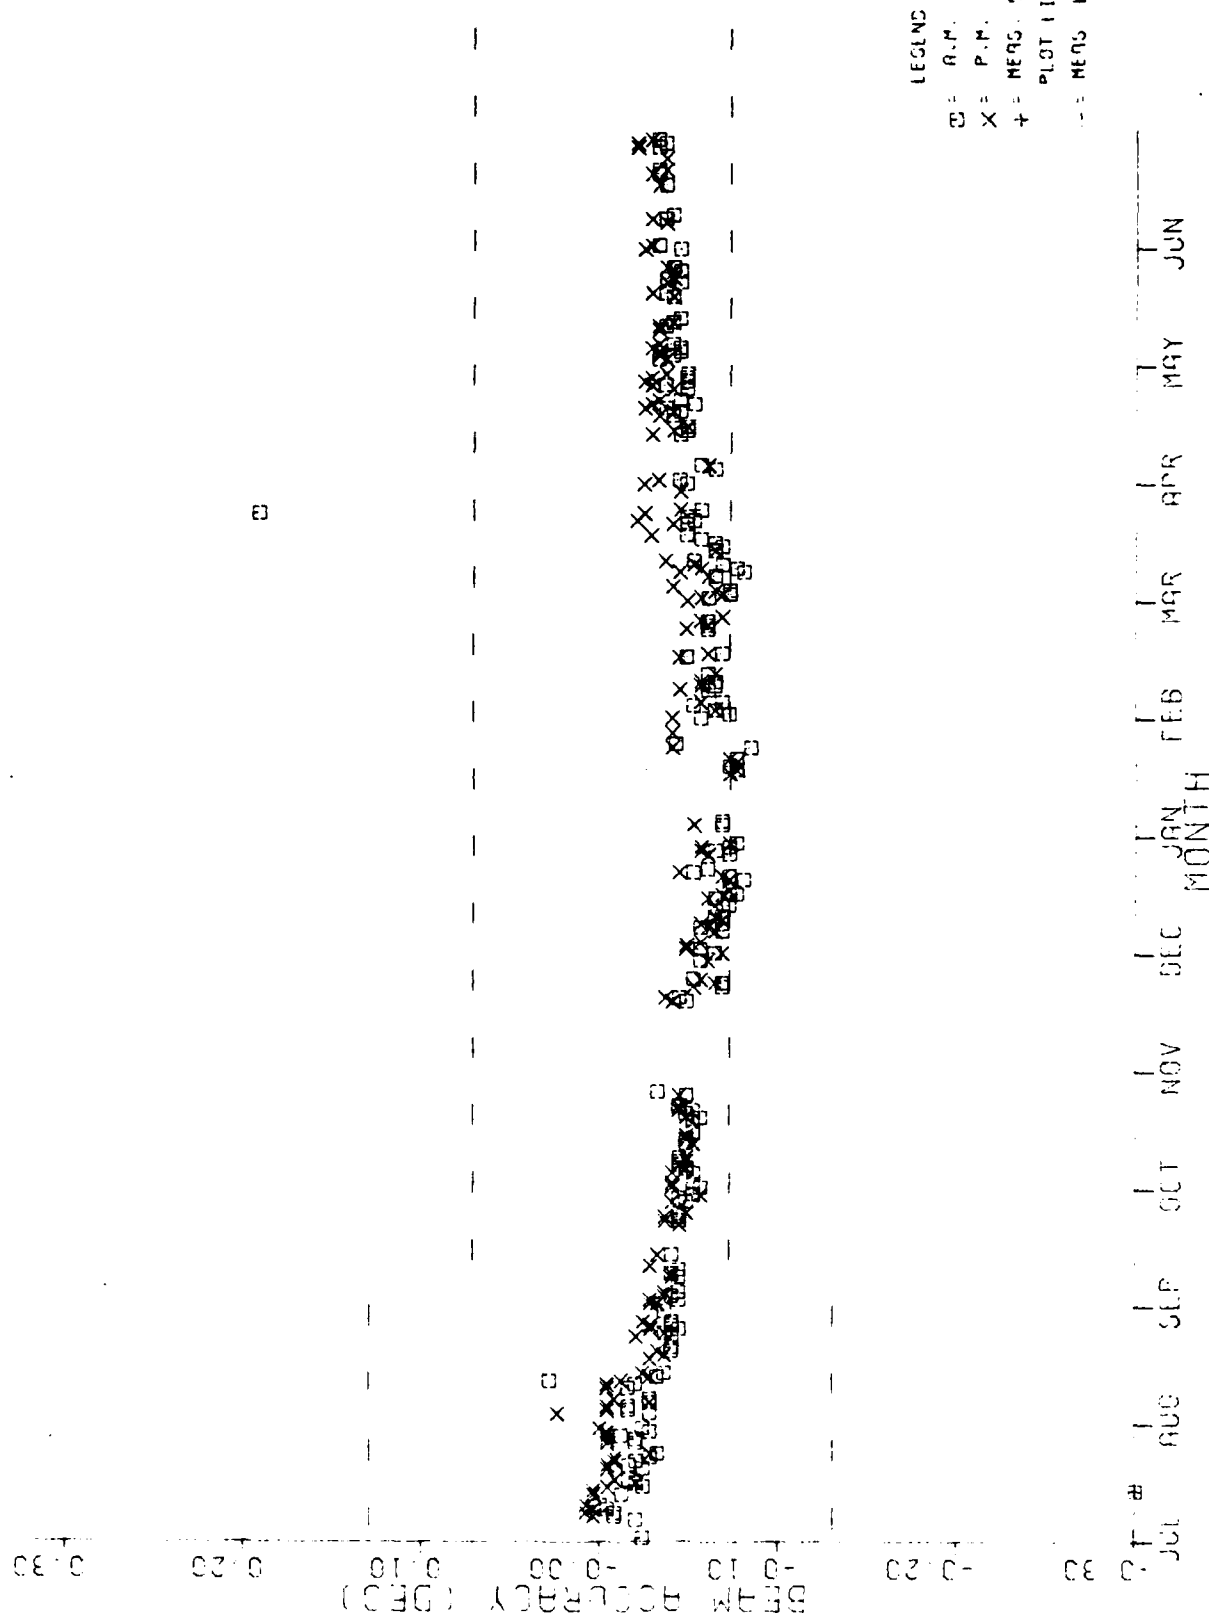
FIGURE 4. AZIMUTH MONITOR, JULY 1981-JUNE 1982, BEAM ACCURACY

Note 1: In figures 4 and 8 the beam accuracy parameter data during the cold months from November through March of both years were near to, touching, or exceeding the -0.072° specification limit; while in the same plots during the hot times of the year that parameter's magnitude was closer to 0.000° or exceeded it in the positive direction. There is a relationship between the seasonal temperatures and a positiveness or negativeness of the plotted data. These two plots also indicate a slightly sinusoidal pattern with a peak to peak difference of about 0.072° except for May and June 1983, in which the parameter becomes more positive, but generally does not exceed the positive specification limit. In March and April 1983, much fewer data points are shown because of the RF SW-1 failure. During May and June 1983, the beam ERP parameter was in executive fault as a result of the "test" RF SW-1 assembly being utilized. Using the "Test" RF SW-1 assembly was the only means to keep the azimuth subsystem operating to collect equipment failure data. This also explains why the a.m. to p.m. variations in (figures D-9 and D-13) for April through June 1983, are greater than at other times over the 2-year RMMS data period. Known reasons for executive fault status are given in table 5, and a discussion on executive fault anomalies is presented in paragraph 4 of this section.

The Russtrak recorder parameter magnitude sensitivity setting could not be resolved less than $+0.080^\circ$, but the alarm limit setting was $+0.072^\circ$ for an executive fault. During the 1981/1982 RMMS data year, executive faults were occurring from December 1981 through March 1982, as seen in figure 4. The values of these executive faults, which are listed in table 5, just exceed the specification limit of -0.072° , but do not exceed -0.080° . This anomaly in data recording resulted in a decreased number of executive faults in the analog Russtrak recorder data. When no executive fault was shown on the Russtrak recorder, the site person did not know it occurred and, consequently, could not report pertinent information in the log data. The actual parameter readings listed in table 5 were taken from computer listings of the RMMS plotted data.

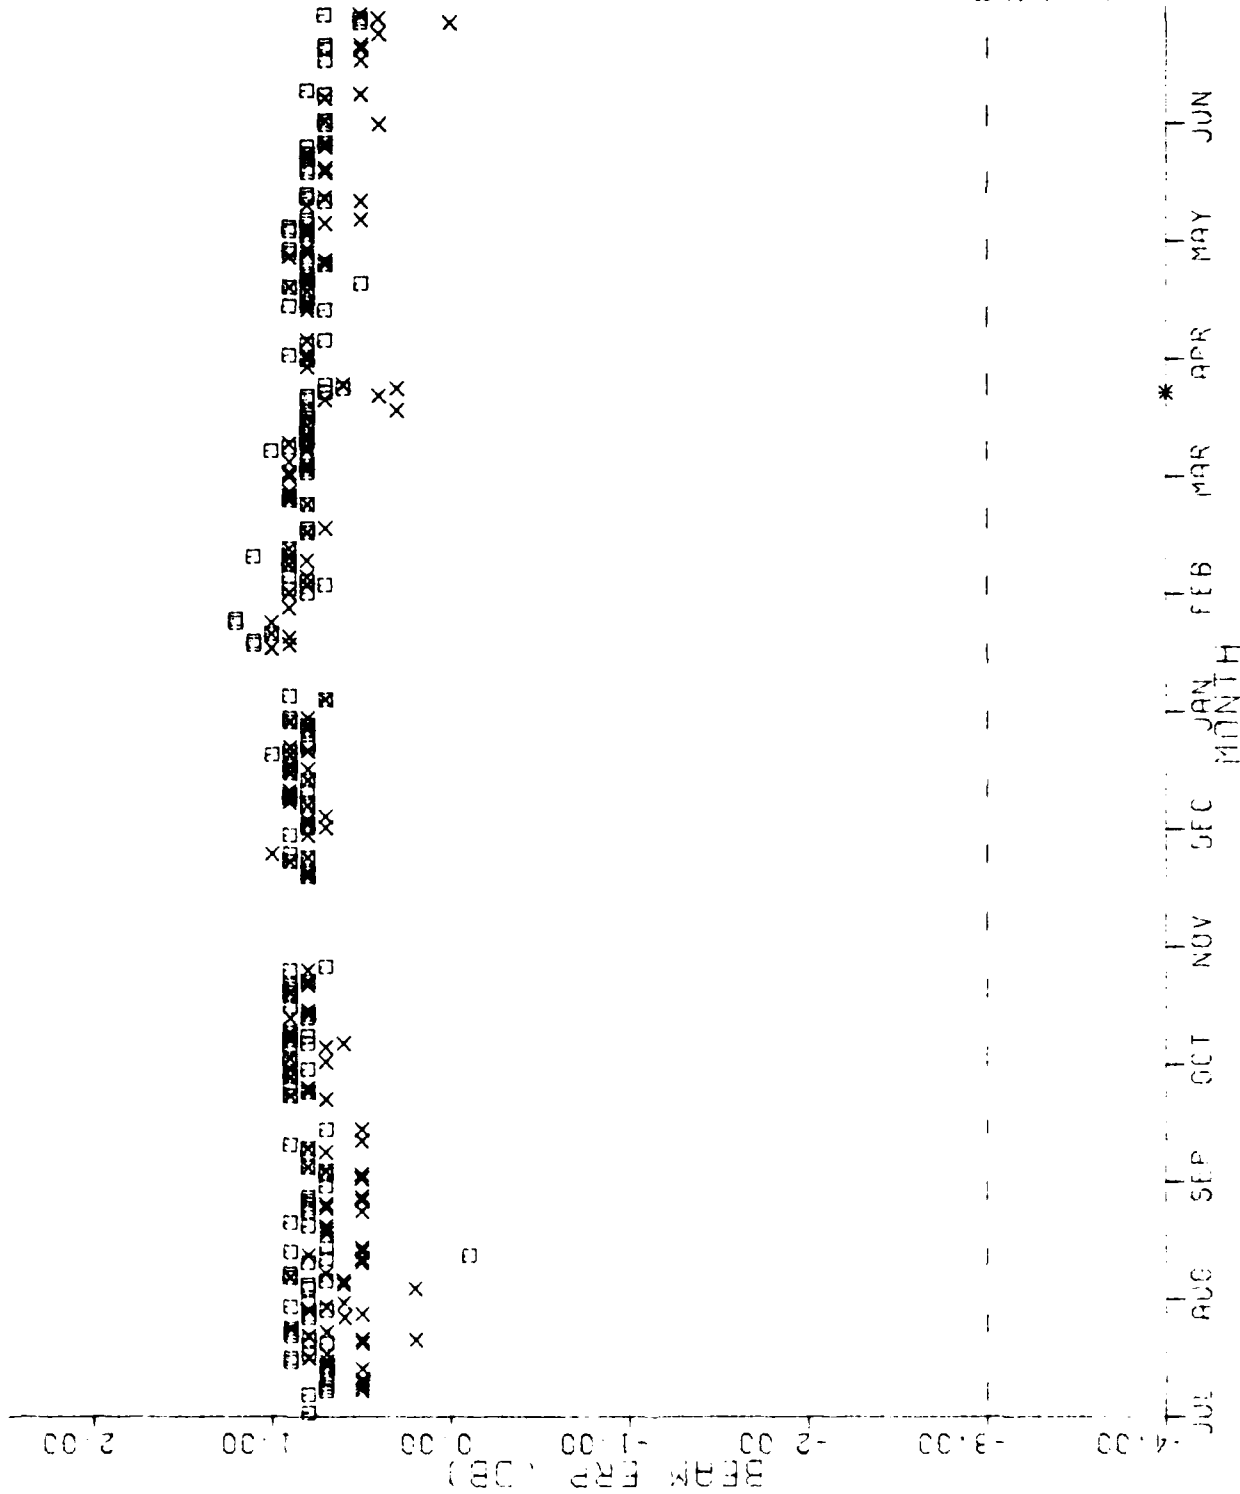
FIGURE 5. AZIMUTH MONITOR, JULY 1981-JUNE 1982, BEAM ERP PARAMETER
COMPOSITE PLOT

Note 2: In figure 5 the beam ERP parameter data approximated a straight line having a central tendency about $+0.75$ dB with a variation of ± 0.25 dB. Similarly, the second RMMS data year, figure 9, for that parameter's data approximated a straight line having a central tendency about $+0.5$ dB with a variation of ± 0.3 dB, except for the months March through June 1983, when the parameter was generally in executive fault status. The "test" RF SW-1 assembly was used then as it was the only means to collect failure data.

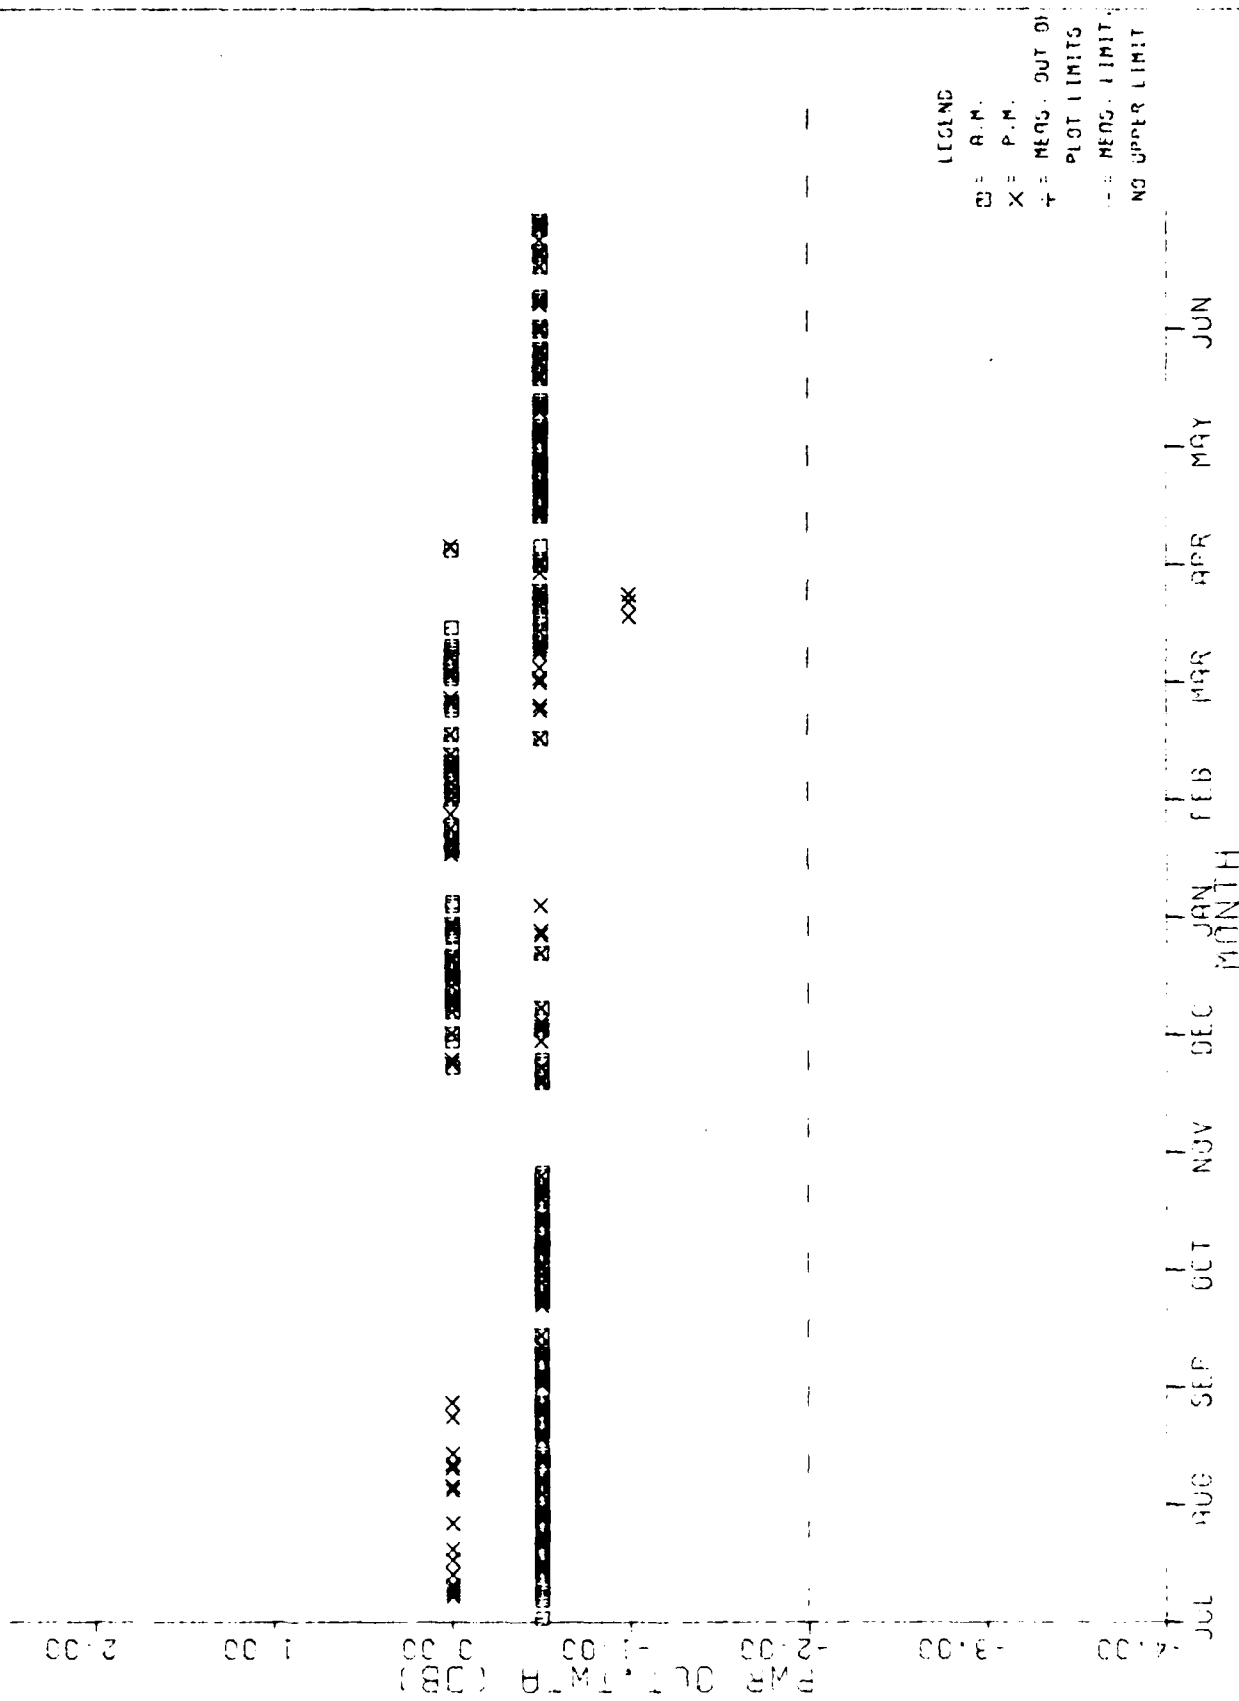
FIGURE 6. AZIMUTH MONITOR, JULY 1981-JUNE 1982, TWTA POWER OUT
PARAMETER COMPOSITE PLOT

Note 5: In figures 6, 10, D-3, D-7, D-11, and D-15 the TWTA power out parameter data are in multiple straight lines parallel to the "date" axis, which is a result of that parameter's resolution of 0.5 dB. All the parameters transmission level data are within specification the first RMMS data year with the data variations between -1.0 and 0.0 dB (figures 6, D-3, and D-7). In the second data year (figures 10, D-11, and D-15), the transmission level data are within specification with data variations between -1.0 and +1.0 dB. The reasons for the parameter executive faults are given in table 5.

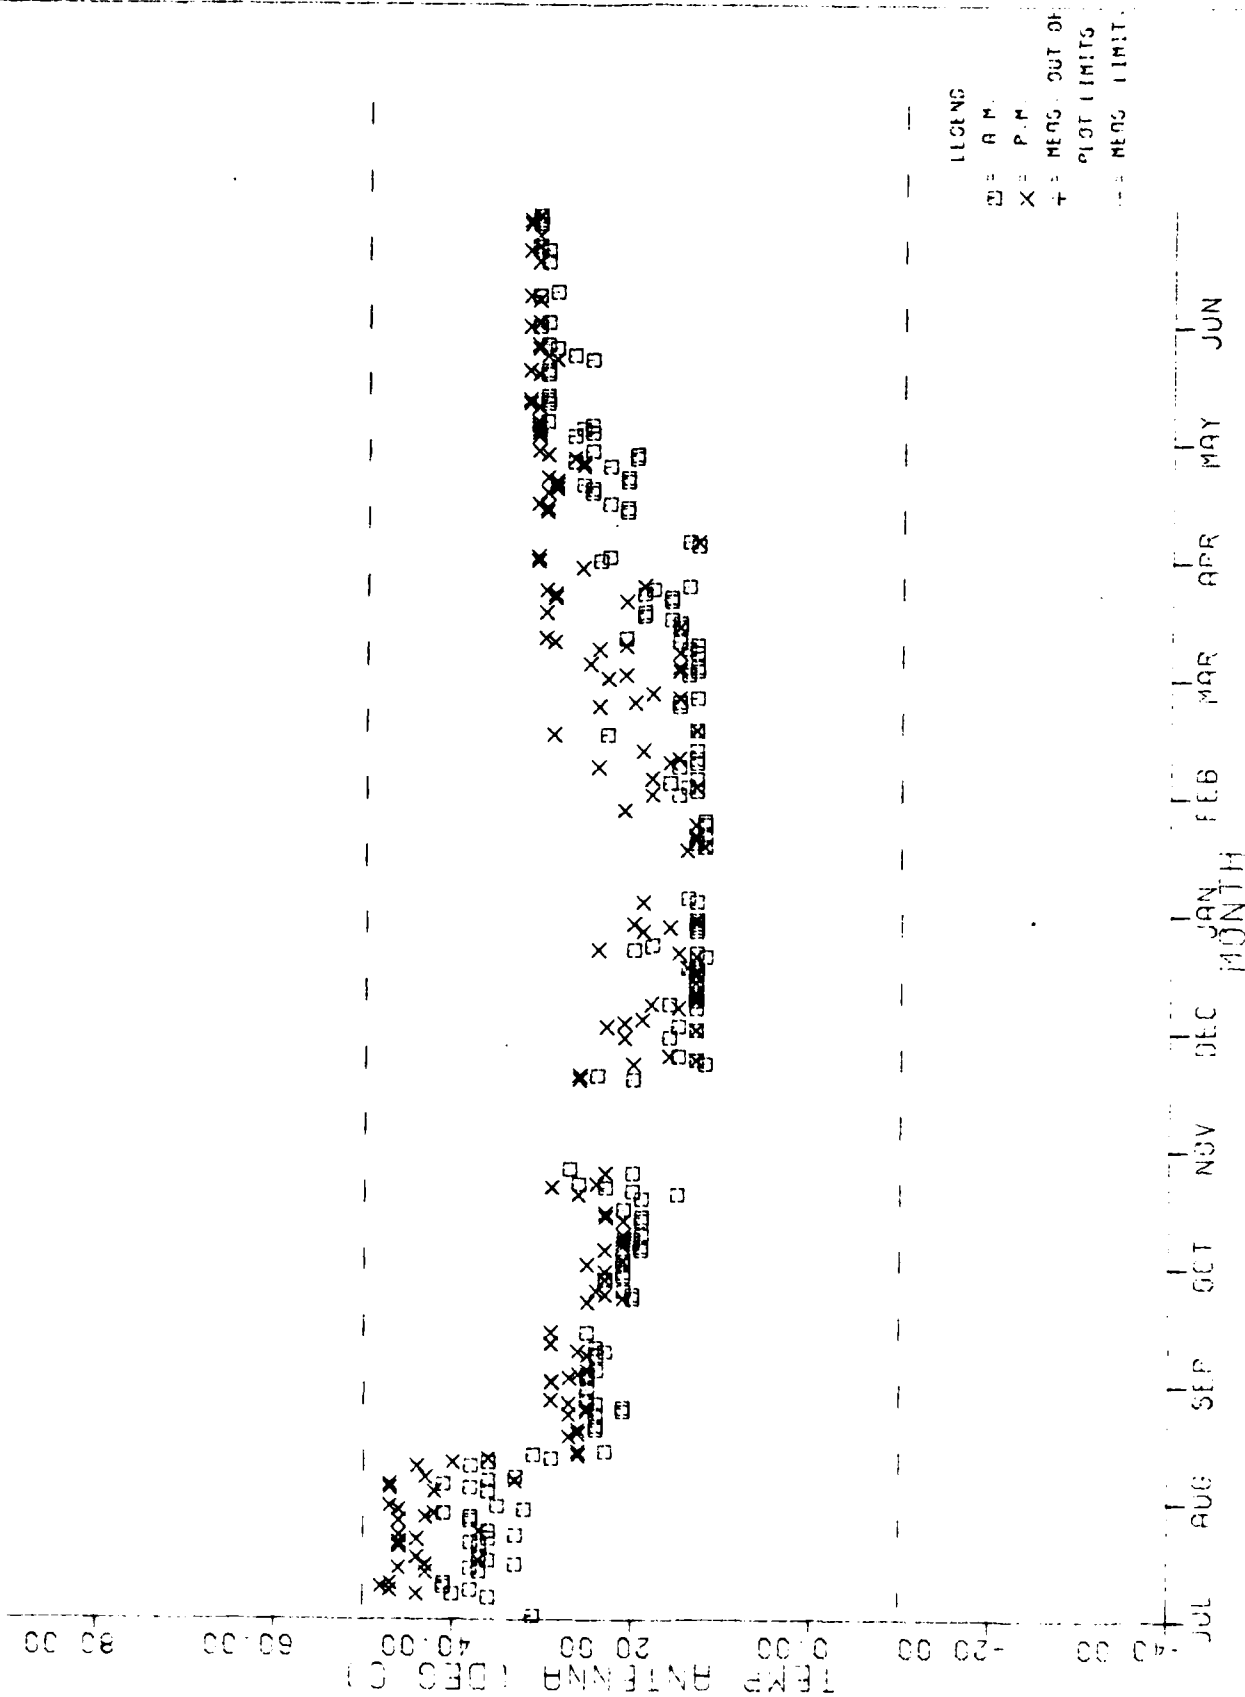
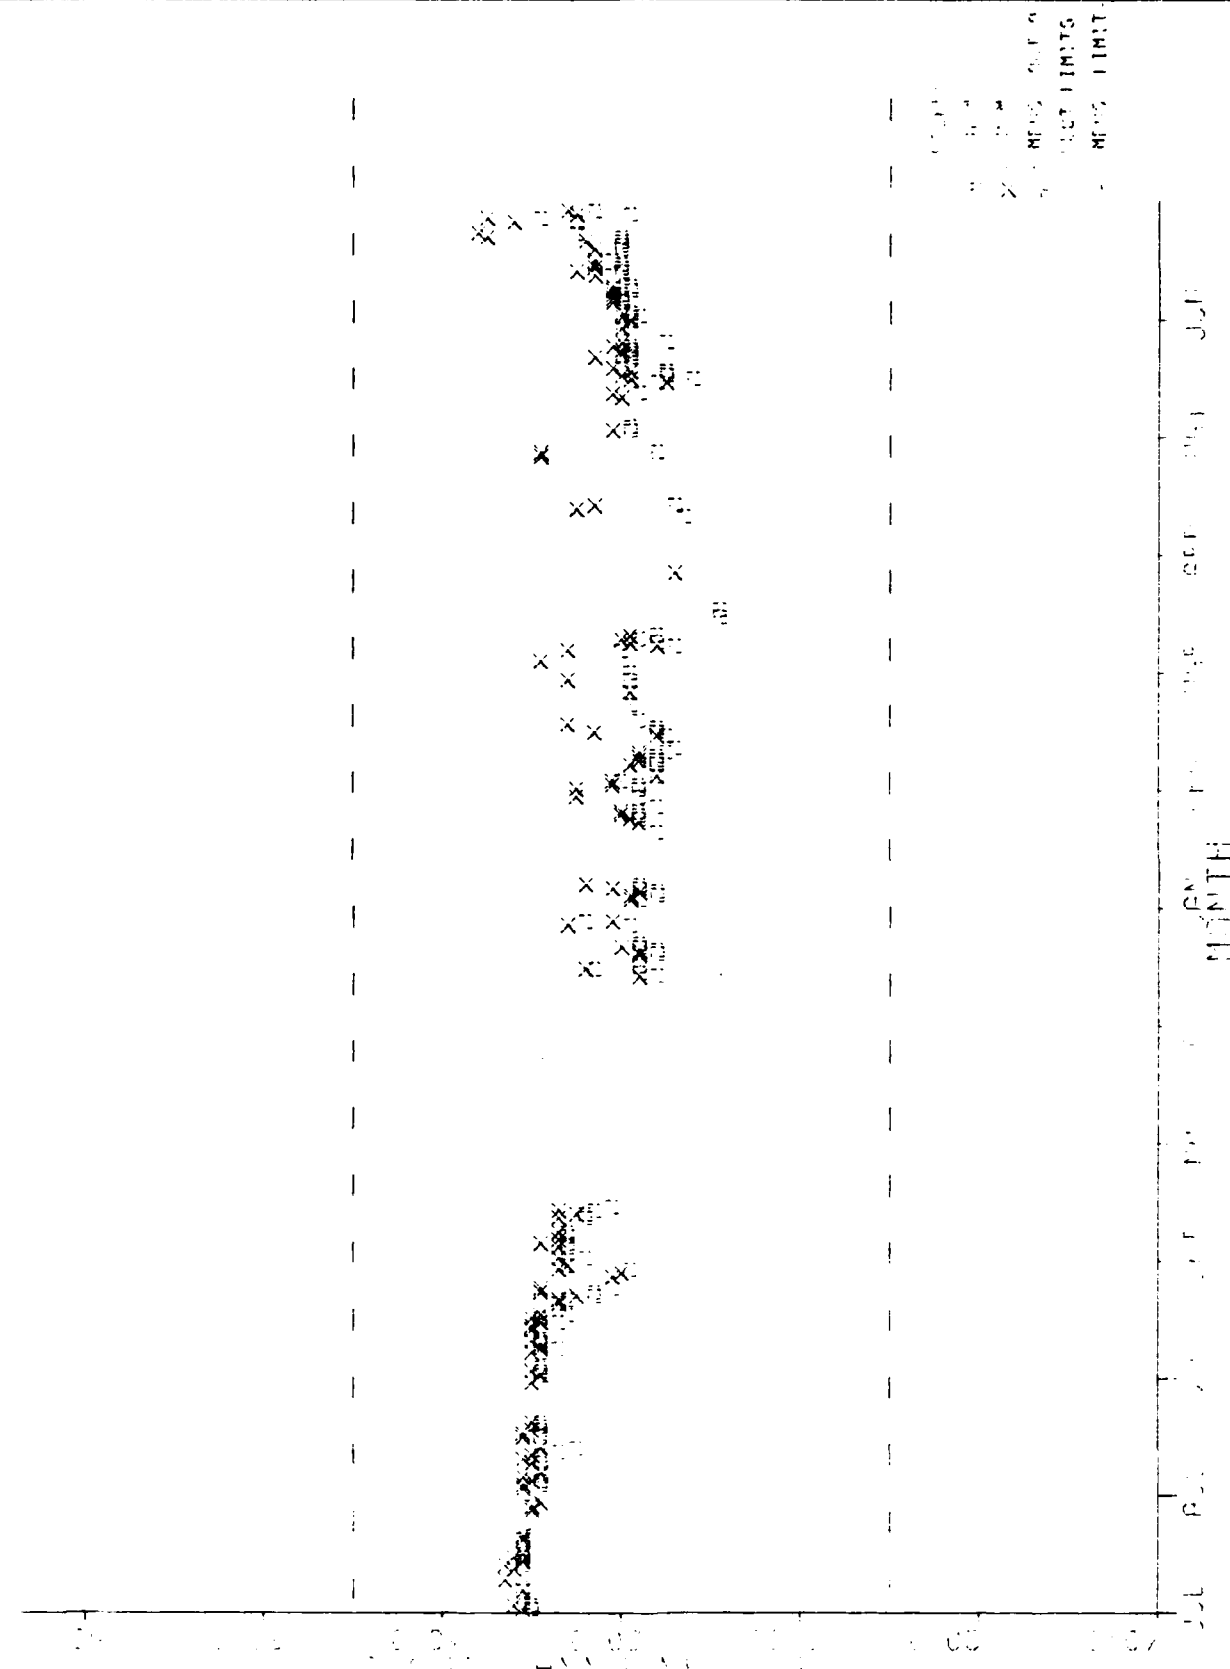
Note 6: In figures 7 and 11 the antenna temperature parameter data form a slightly sinusoidal waveshape over the 2 years of RMMS data. In general, each year compares to the other in peaks and valleys by parameter magnitude and date-axis location. The peak to peak difference is about 20° C, having a maximum value of about 30° C and a minimum value of about 10° C. An exception occurs during July and August 1981, where the plots in figures 7, D-4 and D-8 show the performance of the poorly operating antenna enclosure air conditioning system. The p.m. data figure D-8 show the higher summer afternoon environmental temperatures elevated the antenna enclosure interior temperature.

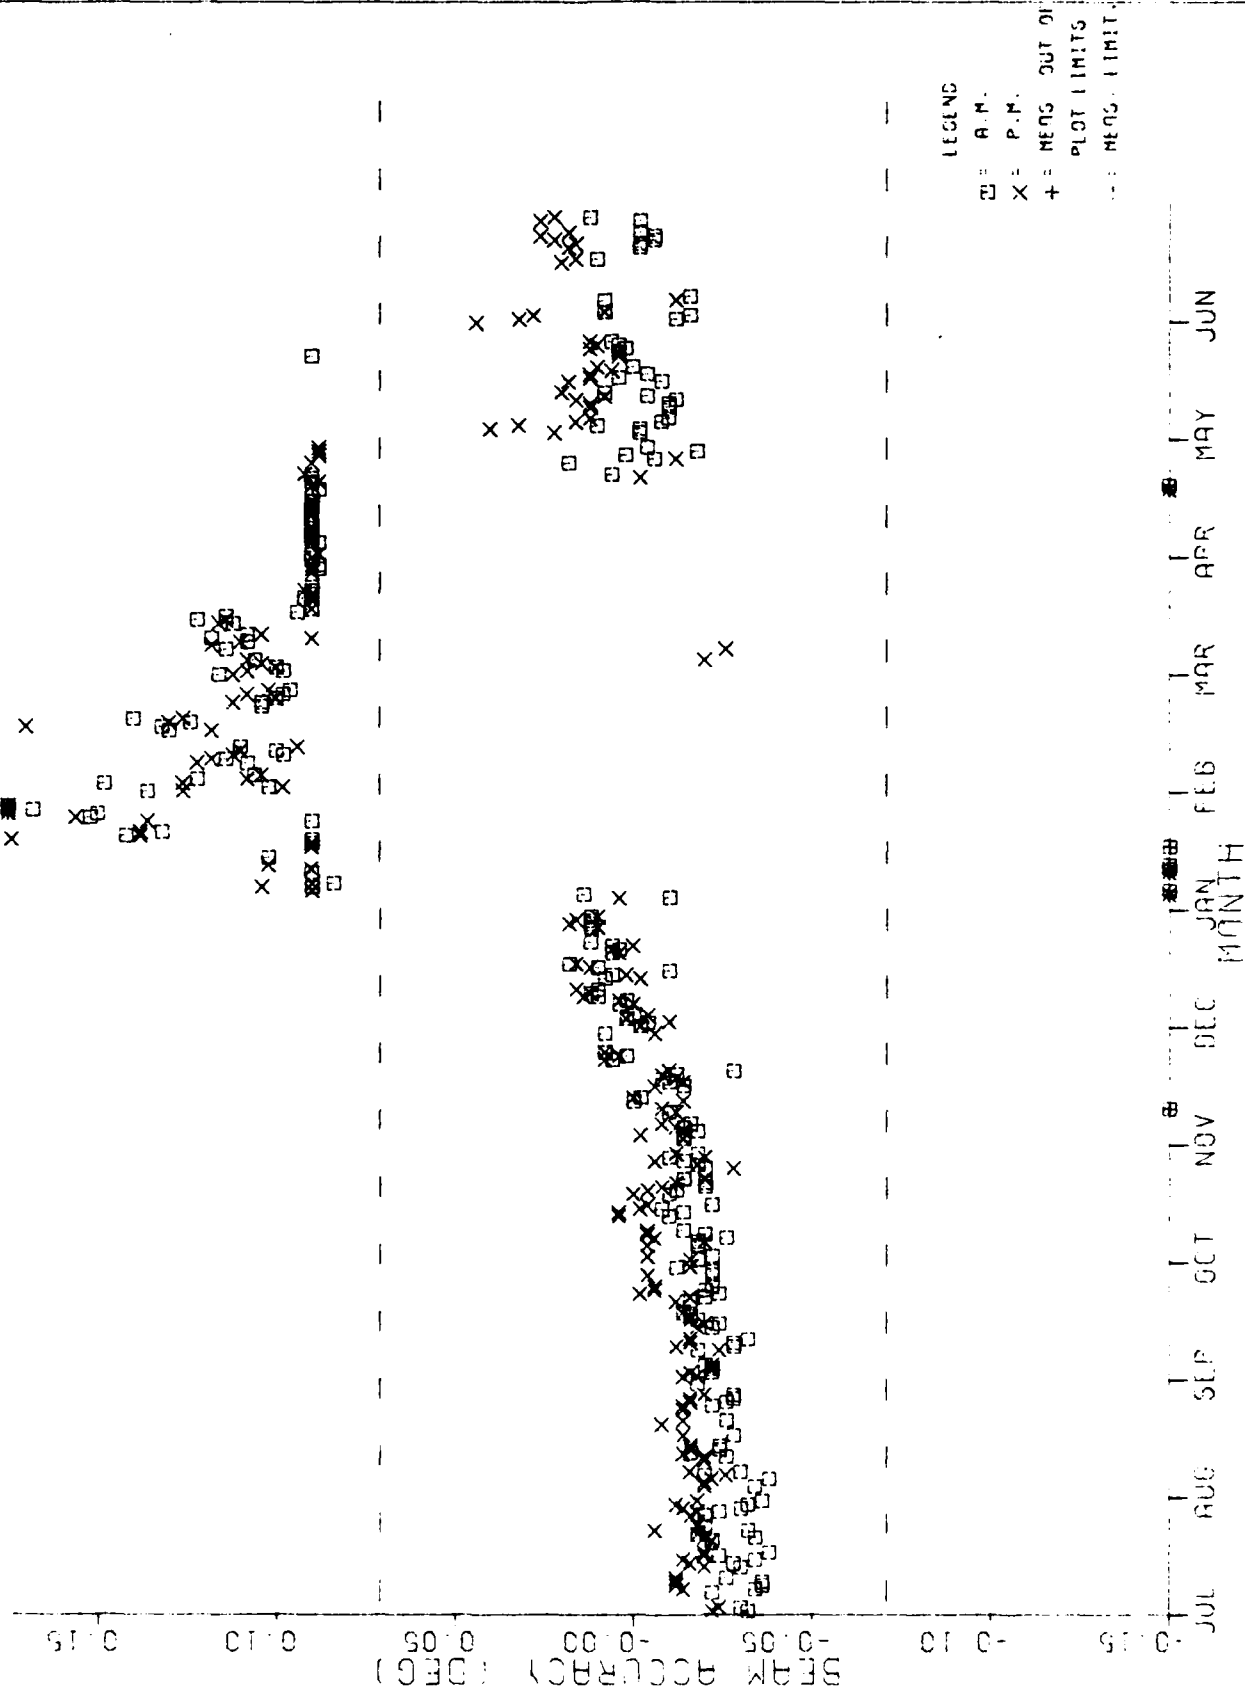
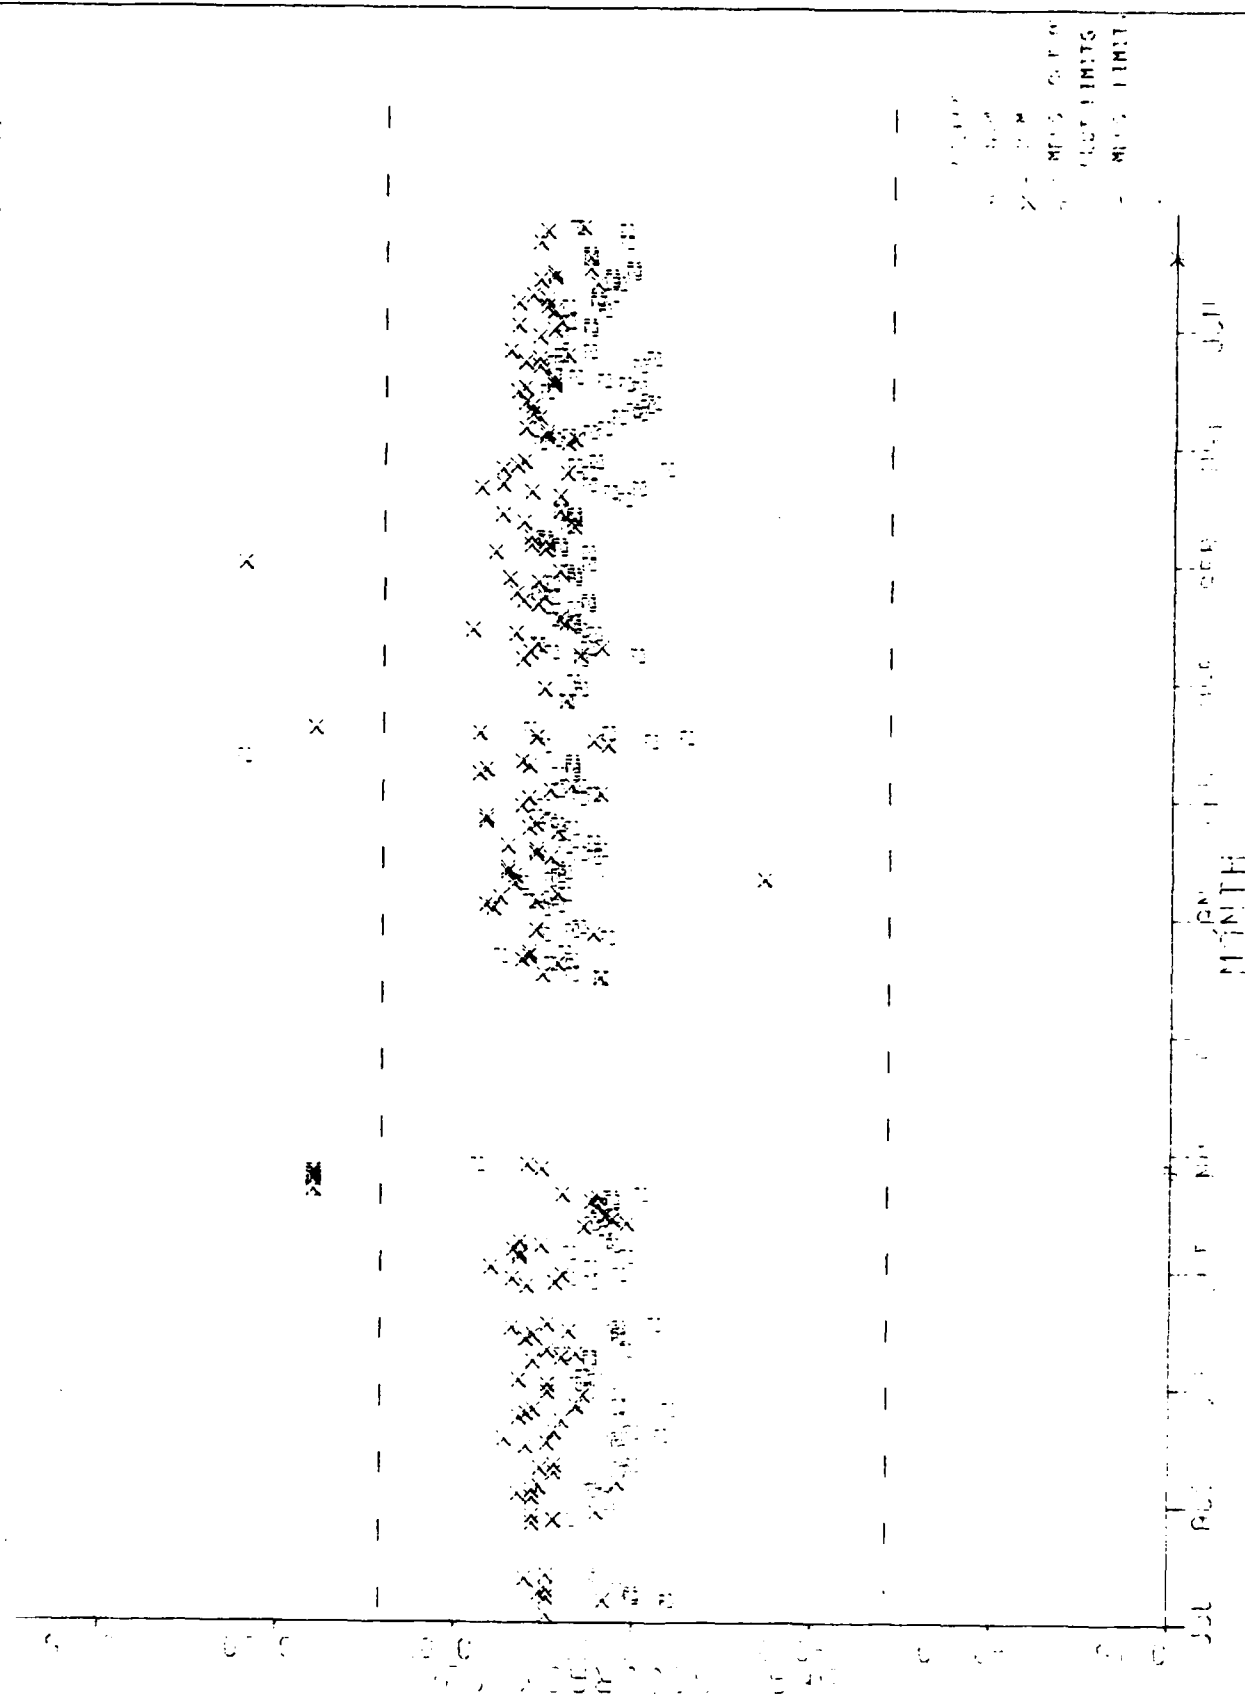
Note 1: In figures 12 and 16, the beam accuracy parameter data did not behave like the AZ subsystem's beam accuracy parameter data in that the data approximated a straight line (rather than slightly sinusoidal) following the installation of the new waveguide during May 1982. Prior to the damaging incident, the original waveguide data may suggest a slightly sinusoidal waveshape, but the amount of data in that last half of 1981 is inadequate to be conclusive. The differences between the a.m. and p.m. data magnitudes are discussed in the following notes 2 and 3. No RMMS data were collected during November 1982 while an azimuth site power line was being repaired (the EL subsystem was shut off).

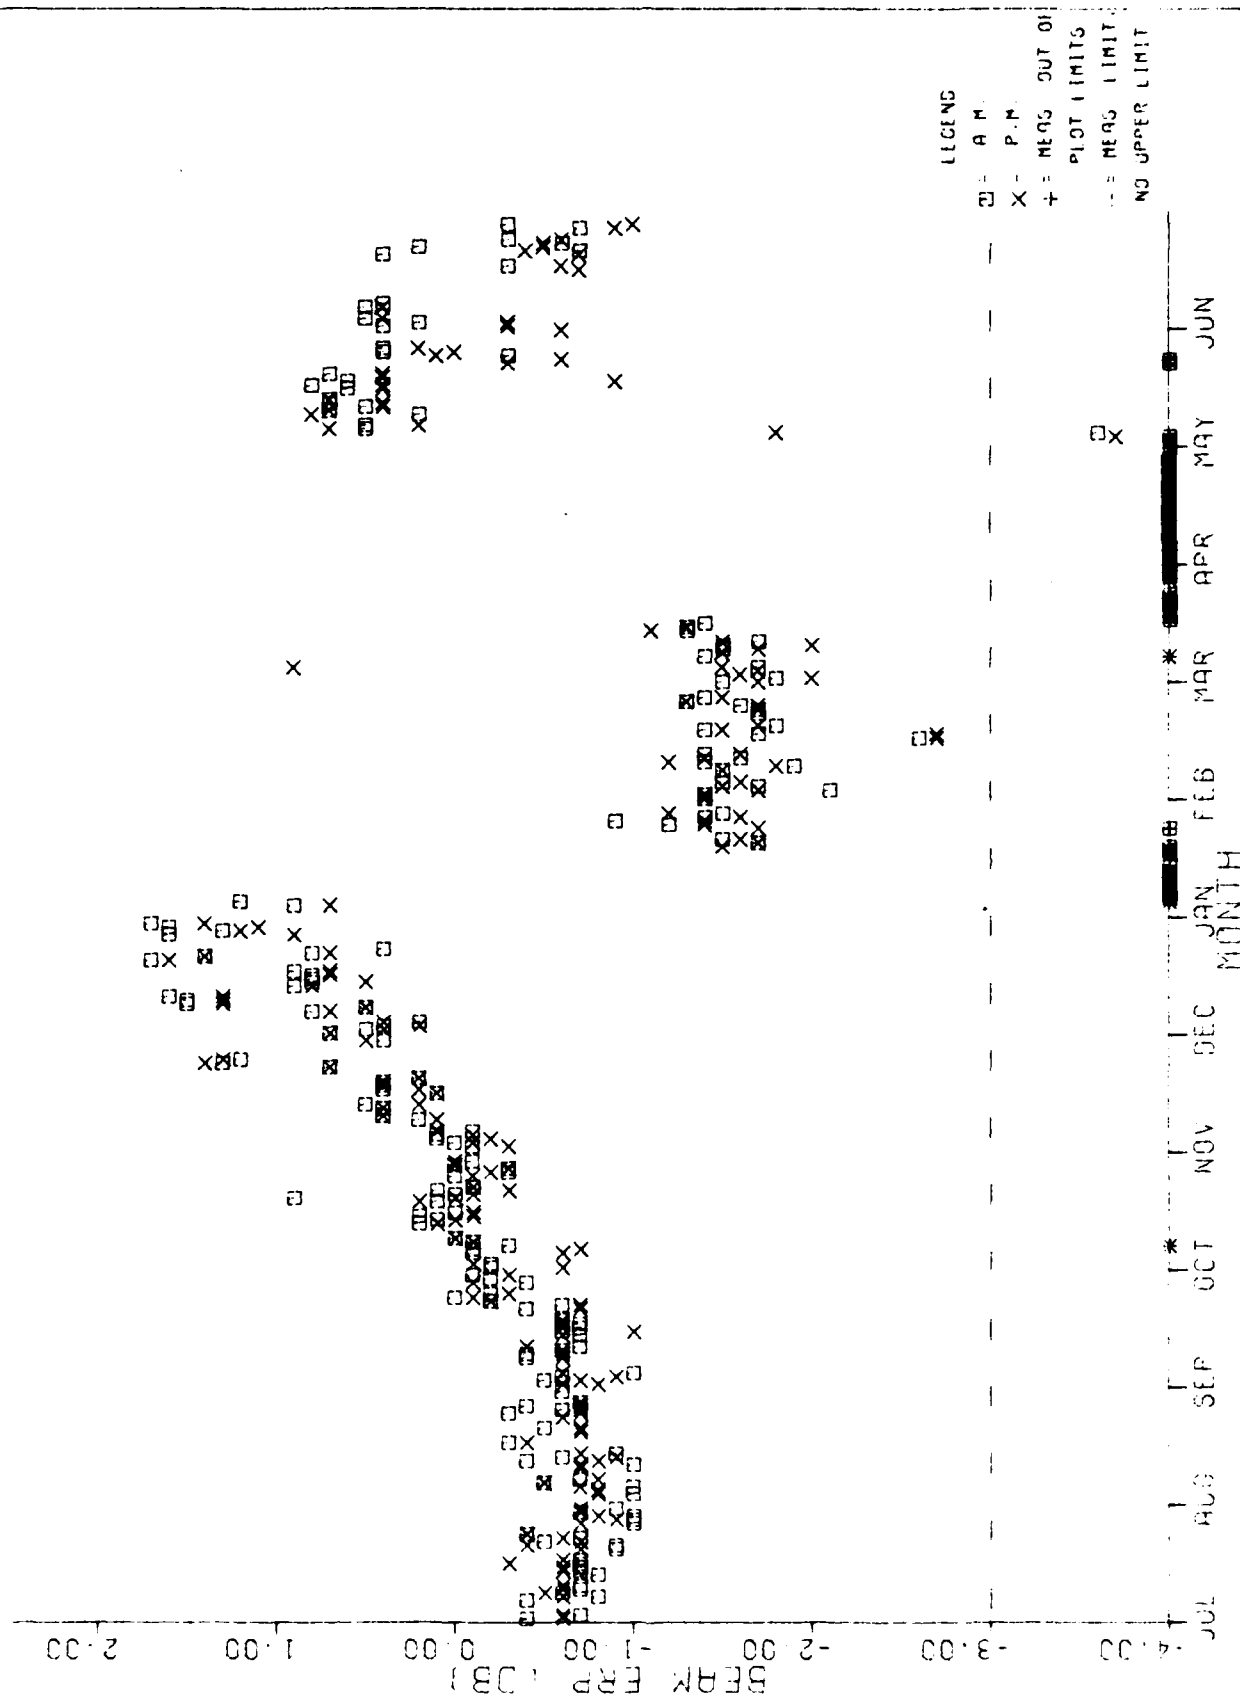
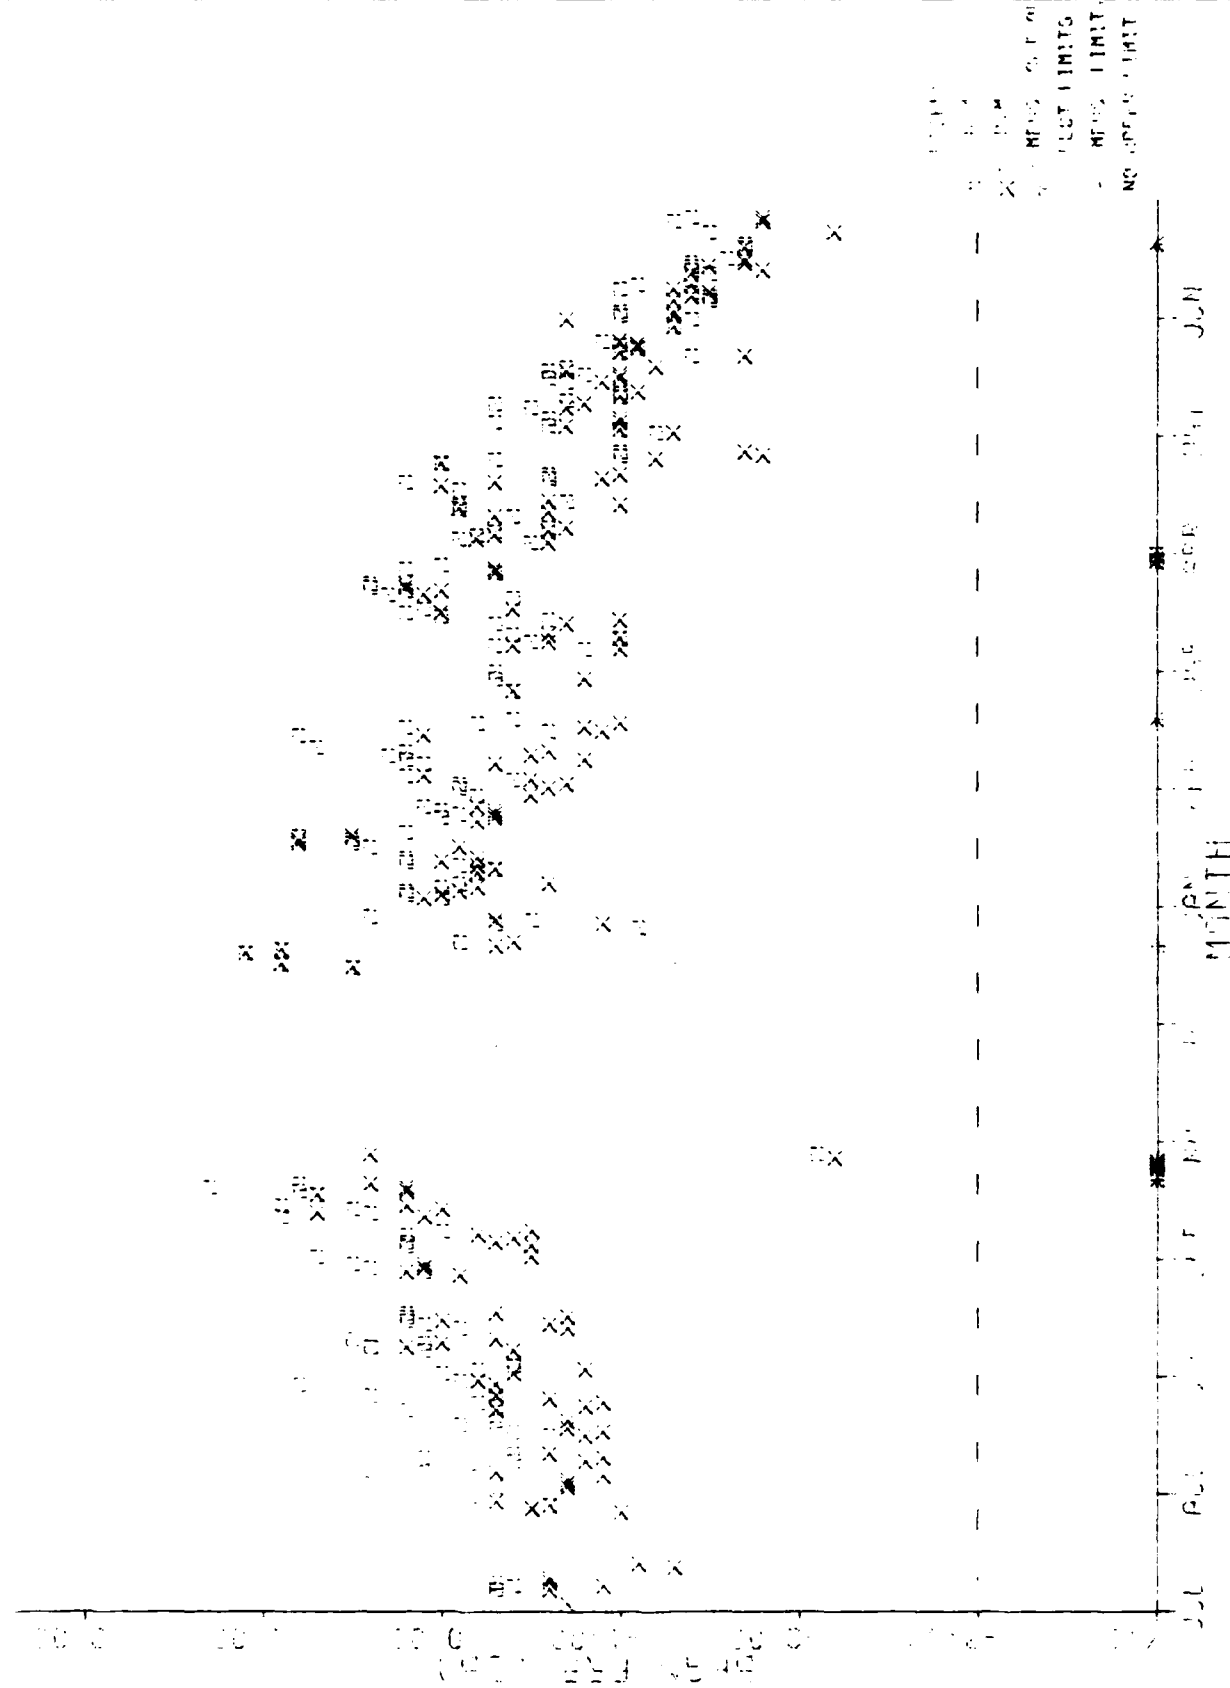
Note 4: Composite yearly data plots (figures 13 and 17) placed end-to-end indicate a slightly sinusoidal waveshape pattern. In both years of RMMS data, during the cold months of December and January, the beam ERP parameter magnitude peaks positive slightly above 1.0 dB, while in the hot months of June, July, and August the most negative peak magnitude was about -2.0 dB. No RMMS data could be collected during November 1982 when both subsystems were not operating due to a power line to the azimuth site being replaced. The effects of operating the subsystem with a damaged waveguide on this parameter are seen in figures 13, D-18, and D-22 during the months of January through March 1982. In this time period water and/or water vapor would take the place of the leaking pressurized nitrogen gas from the waveguide resulting in lowered beam ERP levels.
